LEVEE IMPROVEMENT DISTRICT #19

HURRICANE HARVEY 2017

Levee Management Services
Post Harvey Summary Report

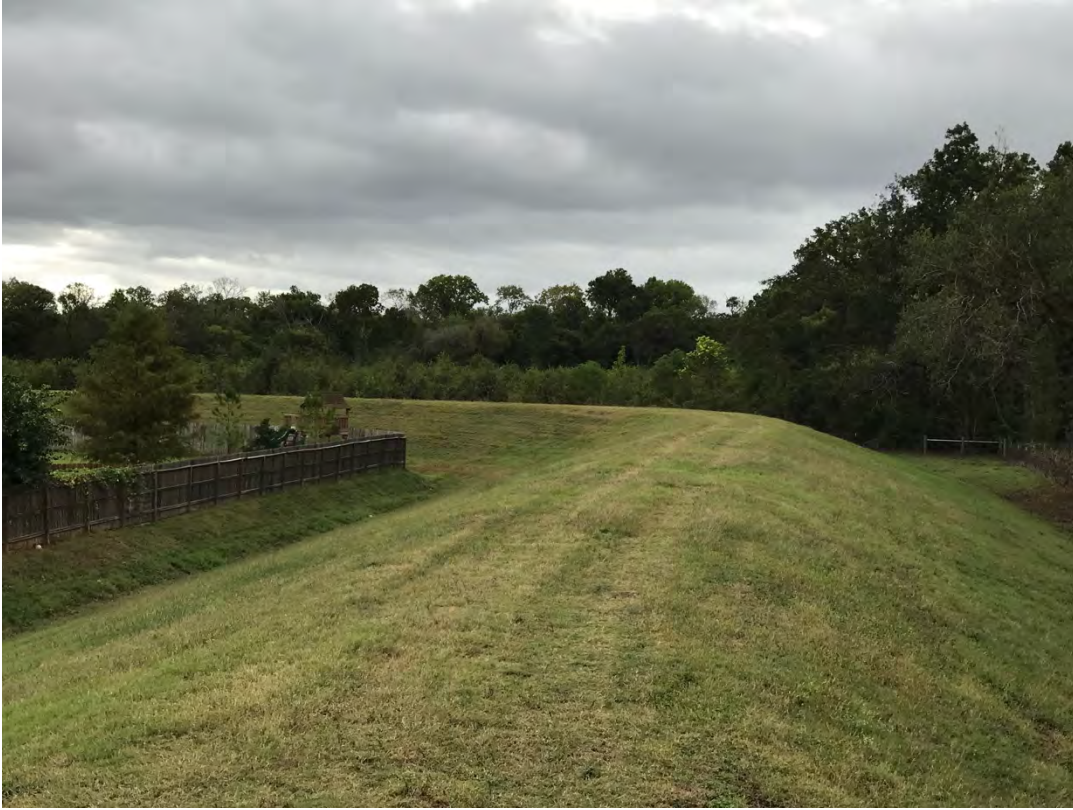
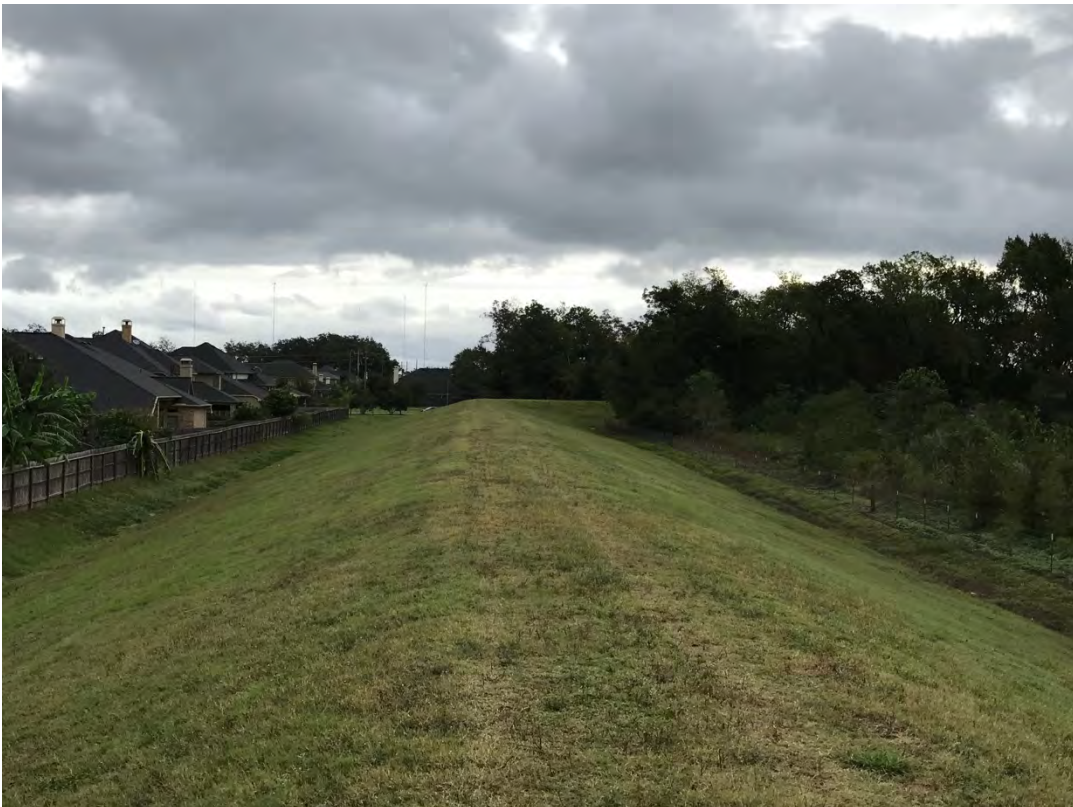
West Entrance Heading South

After detailed inspection, no serious issues were found on the levee in LID 19. No signs of erosion, sloughing or structure damage. Extensive rutting on the levee from LJ Parkway Bridge, South to the Pump Station. Rutting was caused by LMS during inspections of the levee and temporary pump delivery. LMS has already begun repairs of the levee top as approved by the board and coordinated with the district's vegetation contractor for treatment. Trash and debris is throughout the levee system and will be cleared throughout future inspections. High water marks have been taken for the new Brazos River record of the 55.2 crest.

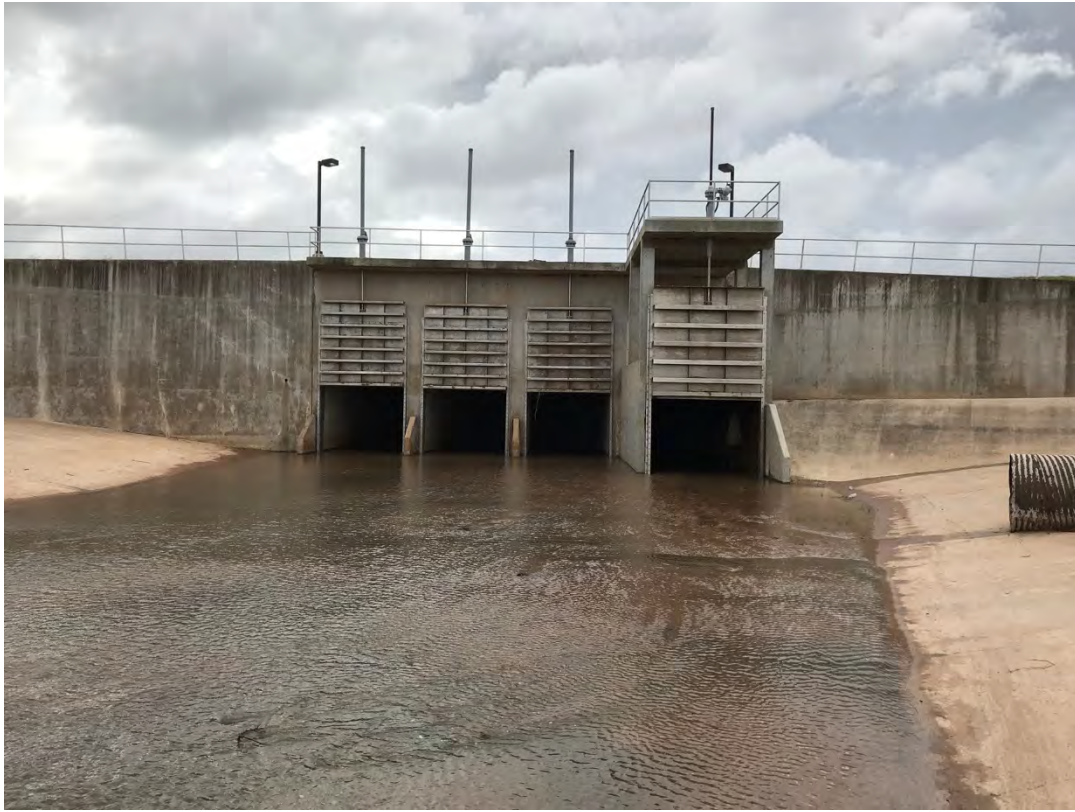
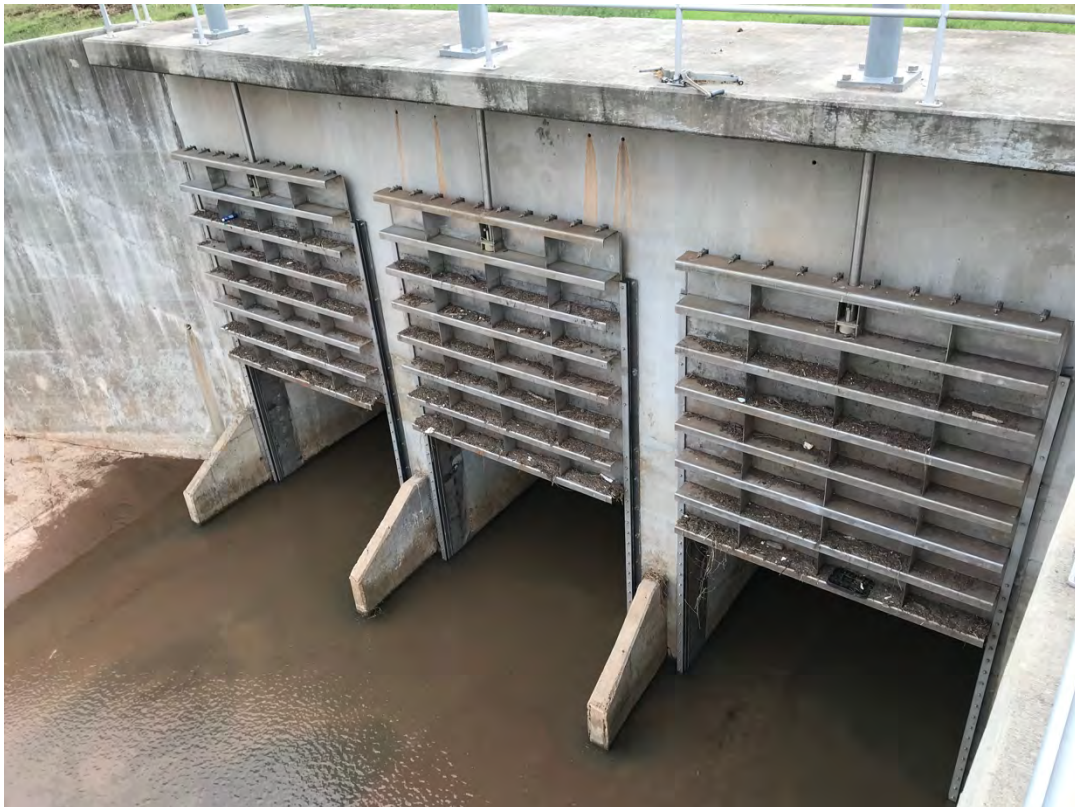
Pump Station Intake Structure

After complete inspection on LID 19 Outfall Structures, no drainage facilities were damaged or collapsed after the heavy rains and river elevations. Extensive clean up throughout the district will take place to clear of silt and debris from concrete structures and open ended pipes to ensure proper drainage in the future. All sluice and flap gates were inspected for damages to gates and hardware. No damages are present on any structure and all gates have been completely cleared of trash, regreased and exercised for proper operation for future events. Down limbs and trees that ended up around the concrete structures have been removed and outfall weep holes that were clogged due to high water, will be cleared in the near future for proper operation of the structure. Some minor erosion is present on the side slopes of the detention pond that can easily be regraded and reseeded upon completion. All drainage facilities in the district did not receive any damage from the rain and river events in this disaster.

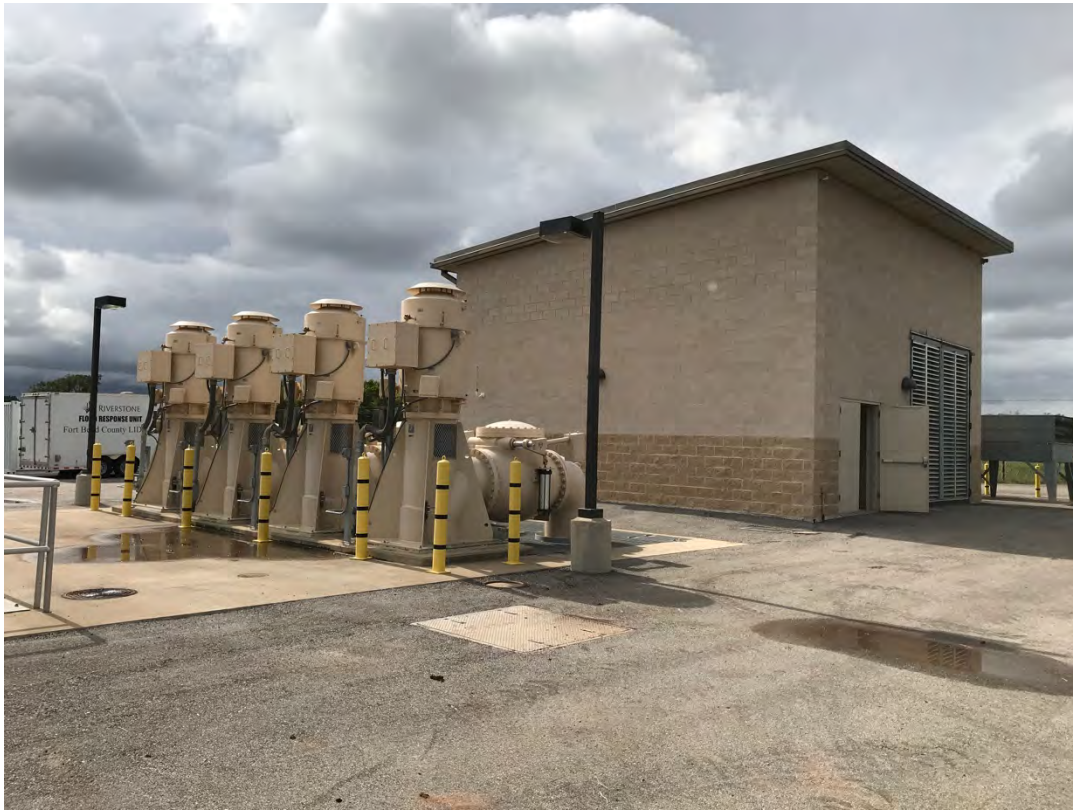
LID 19 Steep Bank Creek Pump Station

A full inspection of the pump station has been completed by both LMS after Hurricane Harvey. The pump station is in full working order; however, one storm water pump shock absorber during shut down bent and a part is on order to replace. The pump is still fully operational and will still pump water at full capacity but the flap gate door slams shut instead of closing slowly. Although the station never lost power, a complete work up on the generator was completed as well to ensure future operation. The computer system in the pump station that monitors pump station operations during the power shortage, fried the monitor to the computer and a sensor to pump 2. All information of pump operations was able to be pulled from the computer, only the screen and sensor needs replaced. Also, noticed during the storm, is the access from the pump station to the levee is very limited. Operator will also recommend a driveway from the pump station building on the levee top be installed for access as well as a working space should additional temporary pumps ever have to be brought in to assist in pumping operations. Pump Station is fully operational should another storm event occur.

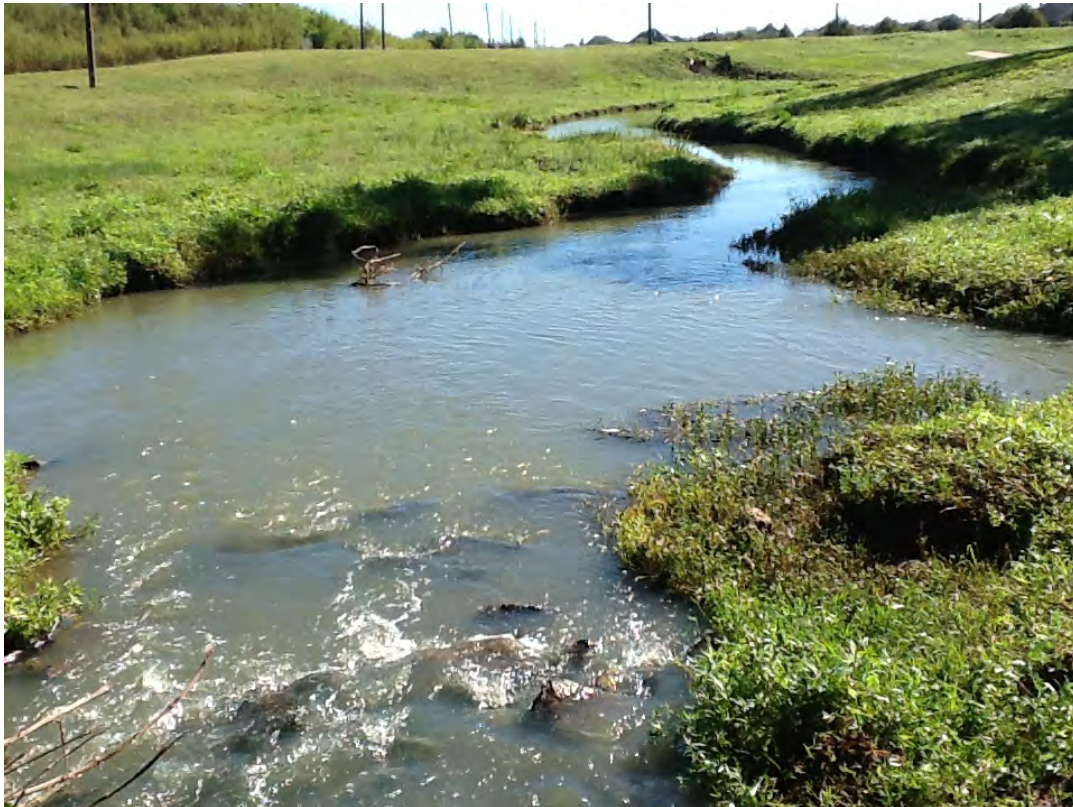
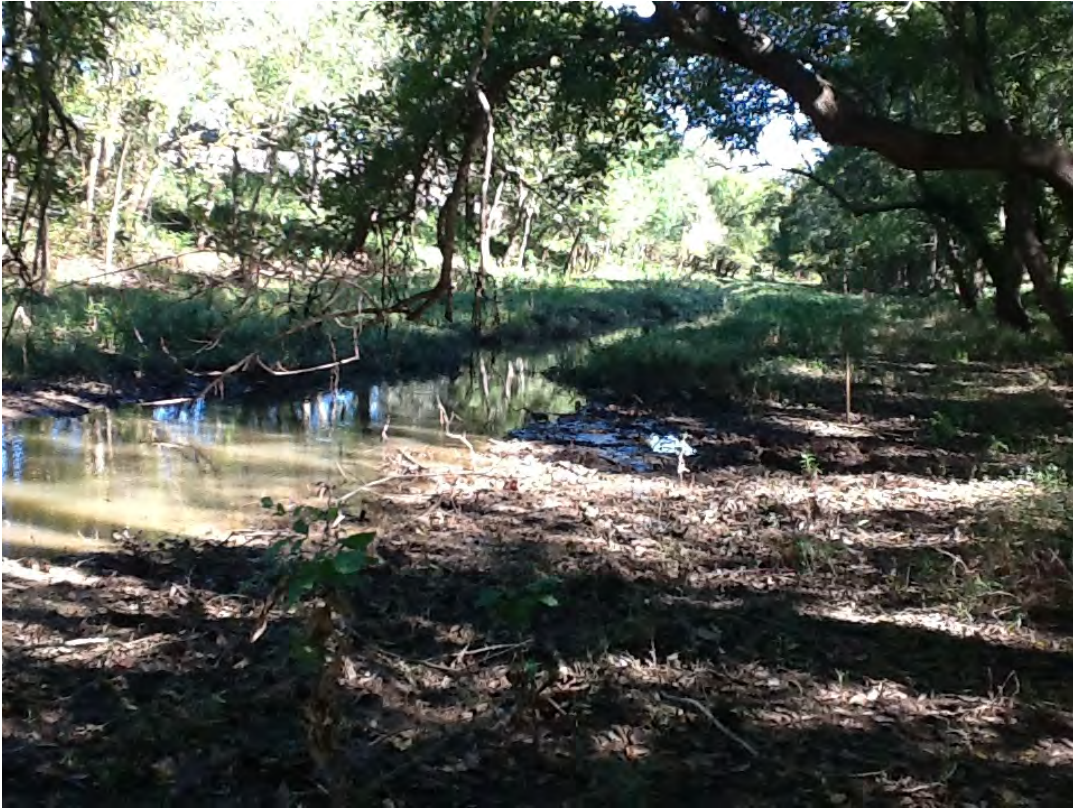
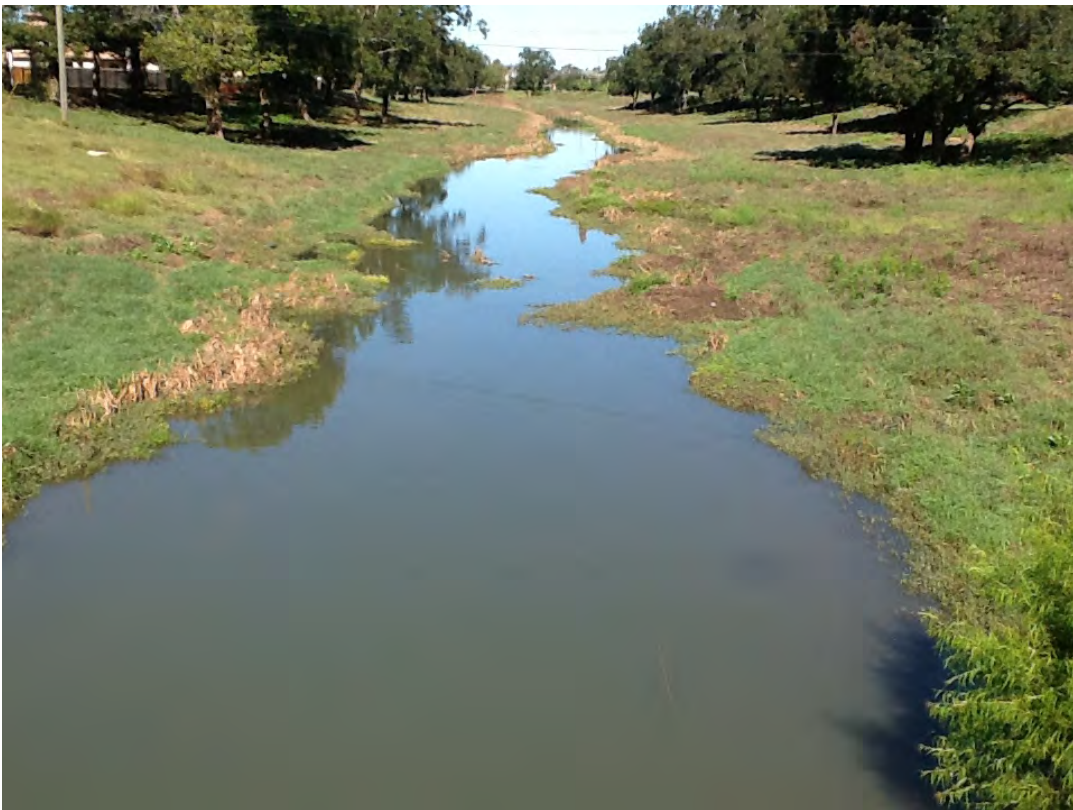
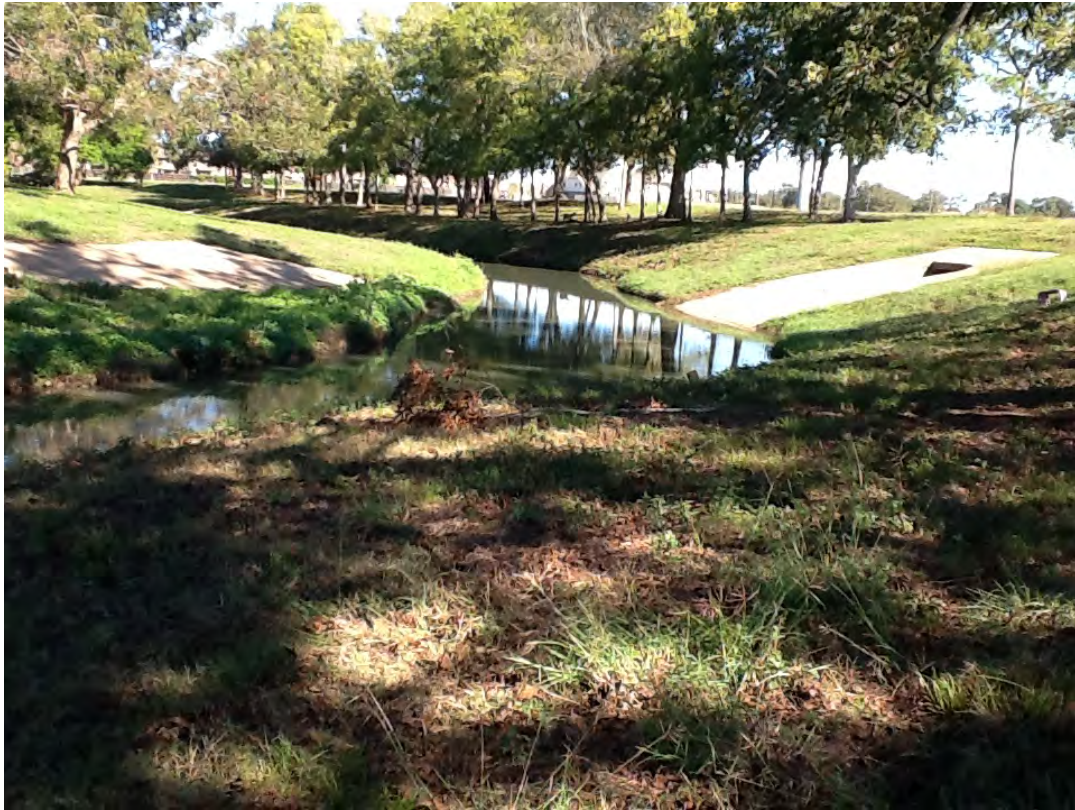
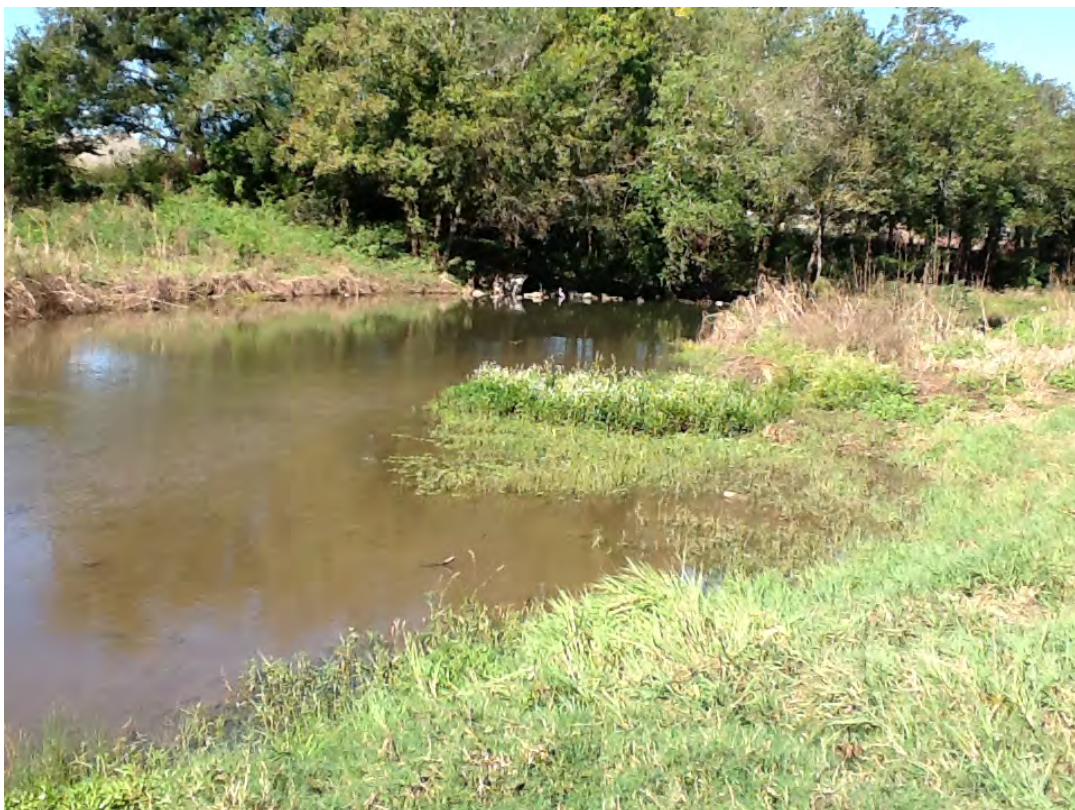
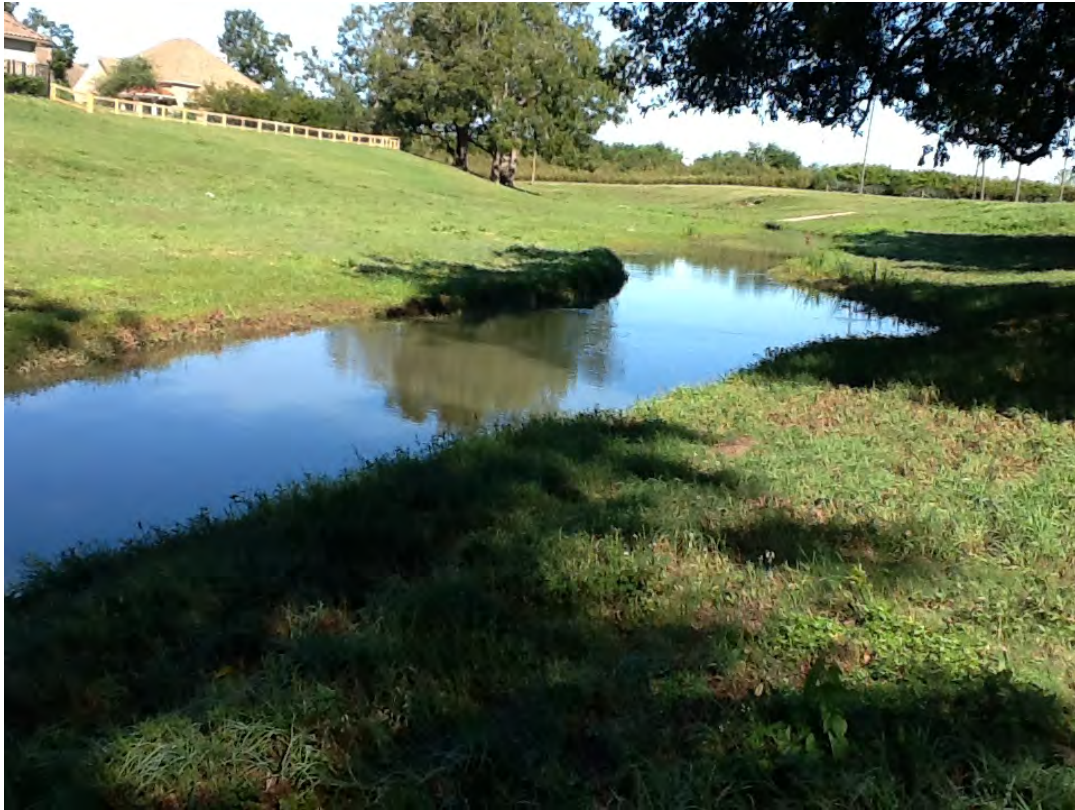
LMS completed a detailed inspection of Steep Bank Creek after Harvey. There are several areas that have down trees and limbs from the storms and water levels experienced during Harvey. An abundance of trash and debris has been left throughout the channel from natural drainage as the water receded in the district. LMS has already contracted to begin clean up in the channel and this work will continue throughout the rest of the year.
