LEVEE IMPROVEMENT DISTRICT #15

HURRICANE HARVEY 2017

Levee Management Services
Post Harvey Summary Report

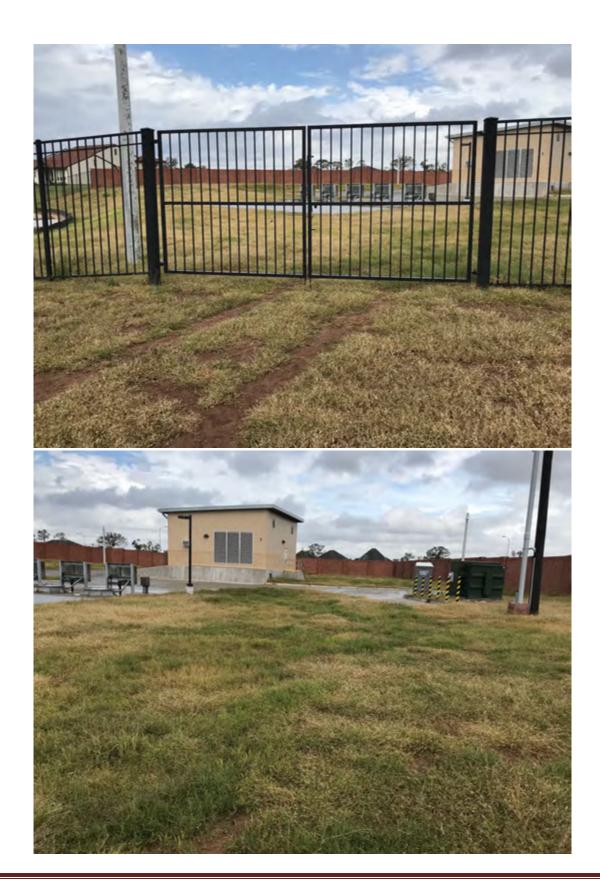
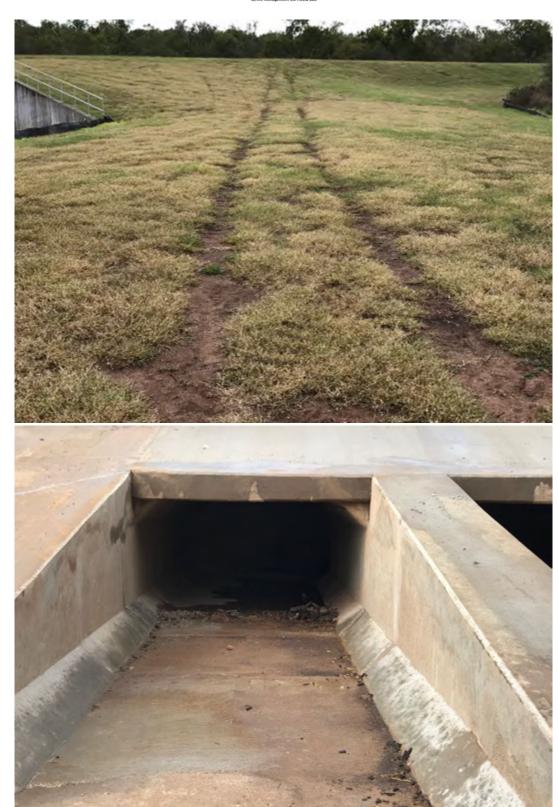
Pump Station:

A full inspection of the pump station has been completed by both LMS and the pump station contractors after Hurricane Harvey. The pump station is in full working order; however, two storm water pump control boxes will need reworked as it was noticed some water in the electrical panel which could cause an electrical short if used in the future. Although the station never lost power, a complete work up on the generator was completed as well to ensure future operation. The computer system in the pump station that monitors pump station operations was not operating as designed as it was not commissioned yet before the storm.

Adjustments on the computer monitoring system will need to be made before it is fully operational. The intake tunnel for the pump station worked as designed, however, operator will recommend a bar screen be installed to keep debris from going into the tunnel during operation. A board request will be made to prevent damage to the pumps in the future. Also noticed during the storm is the access from the pump station to the levee is very limited. Operator will also recommend a driveway from the pump station building to the levee top be installed for access as well as a working space should additional temporary pumps ever have to be brought in to assist in pumping operations.

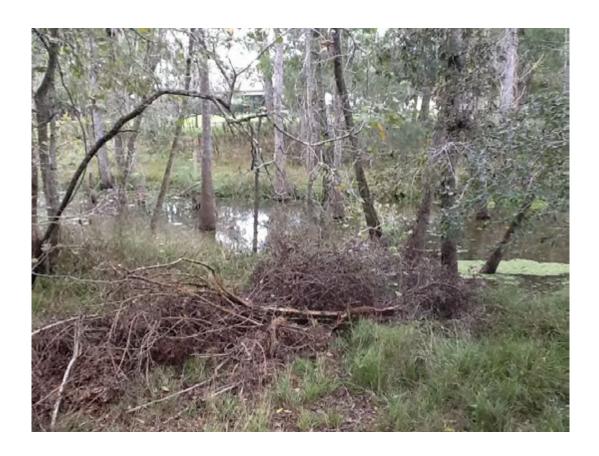
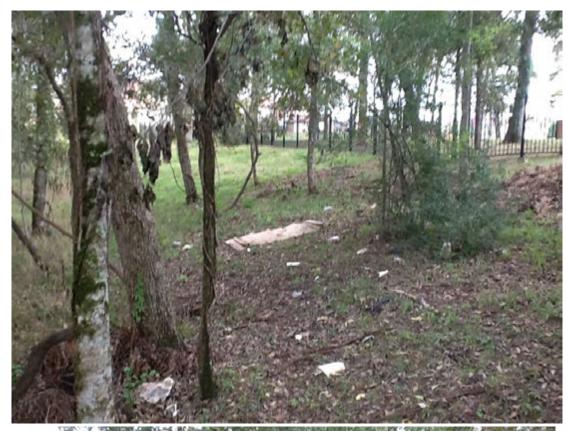
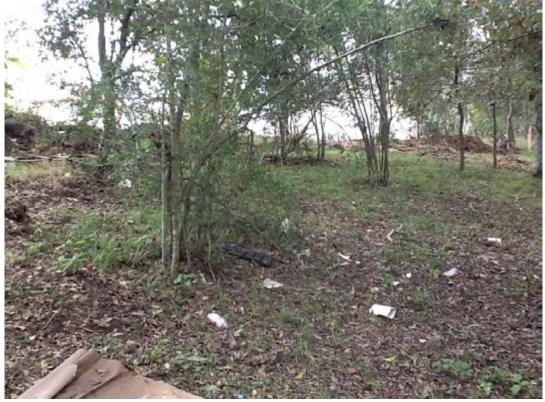
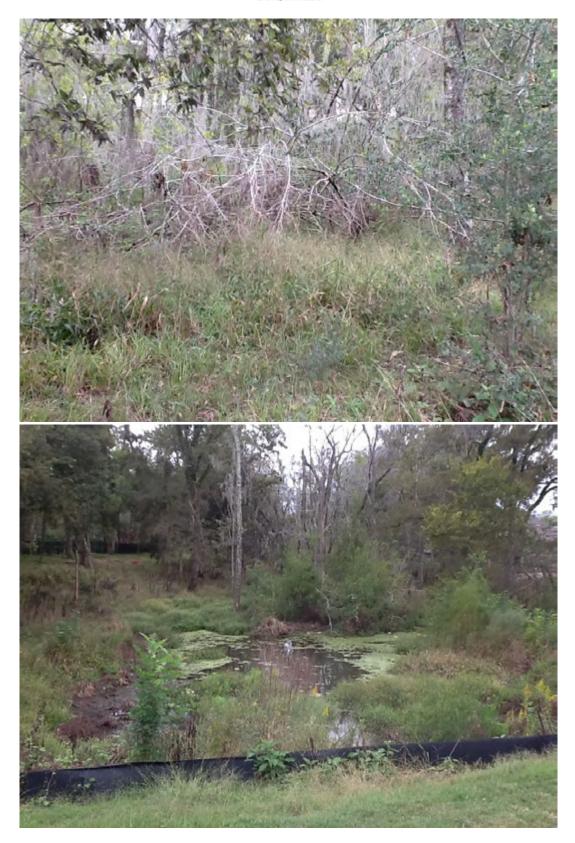
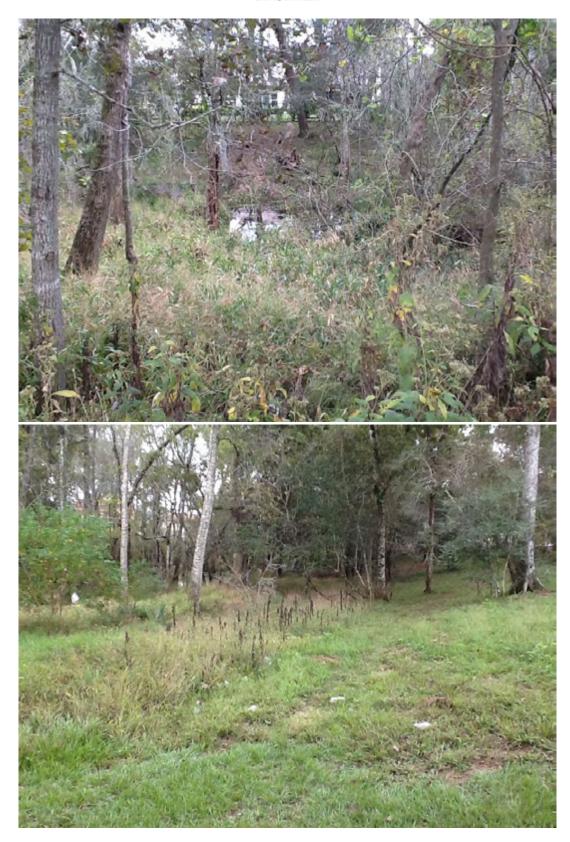
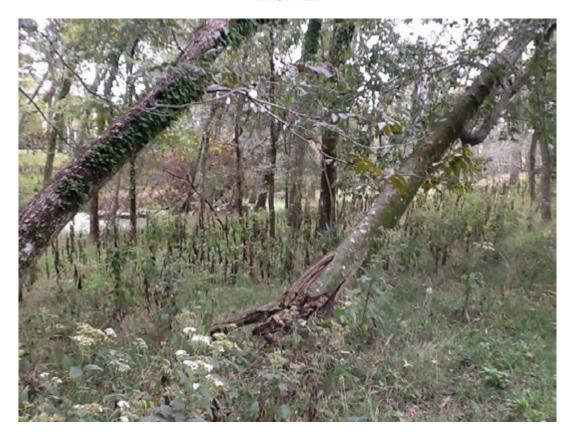
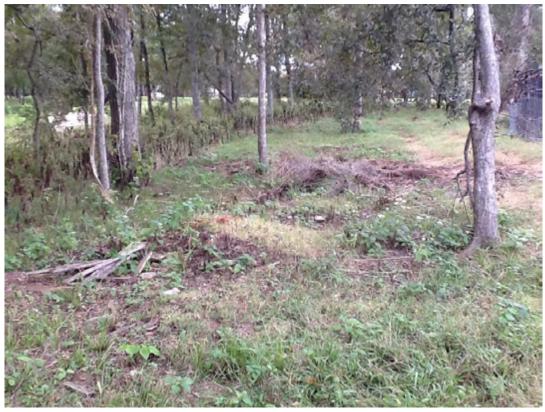
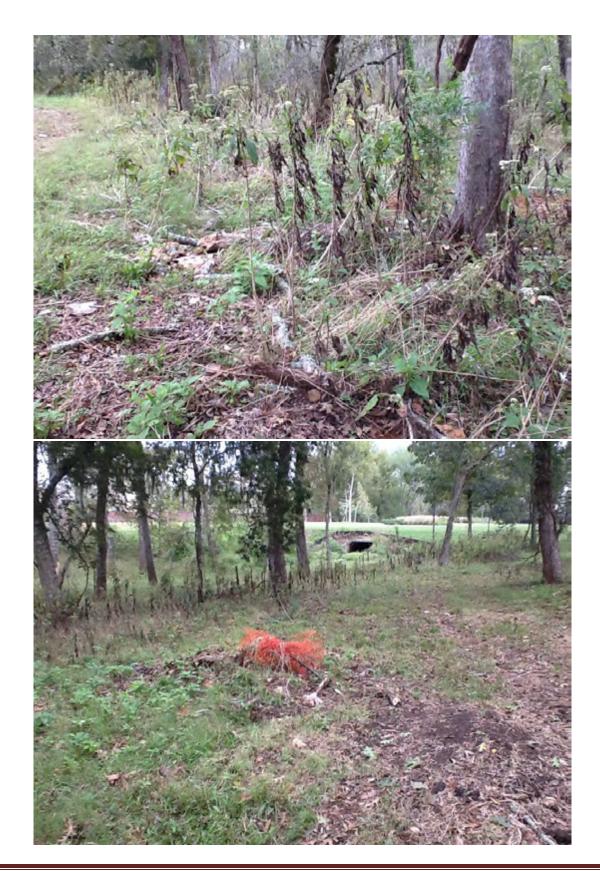
Alcorn Bayou Drainage:

LMS completed a detailed inspection of Alcorn Bayou after Harvey. There are several areas that have down trees and limbs from the storms and water levels experienced during Harvey. An abundance of trash and debris has been left throughout the channel from natural drainage as the water receded in the district. LMS has already contracted to begin clean up in the channel and this work will continue throughout the rest of the year.
