FORT BEND COUNTY LEVEE IMPROVEMENT DISTRICT NO. 19

AFTER ACTION REPORT

BY COSTELLO, INC.

HURRICANE HARVEY – 2017

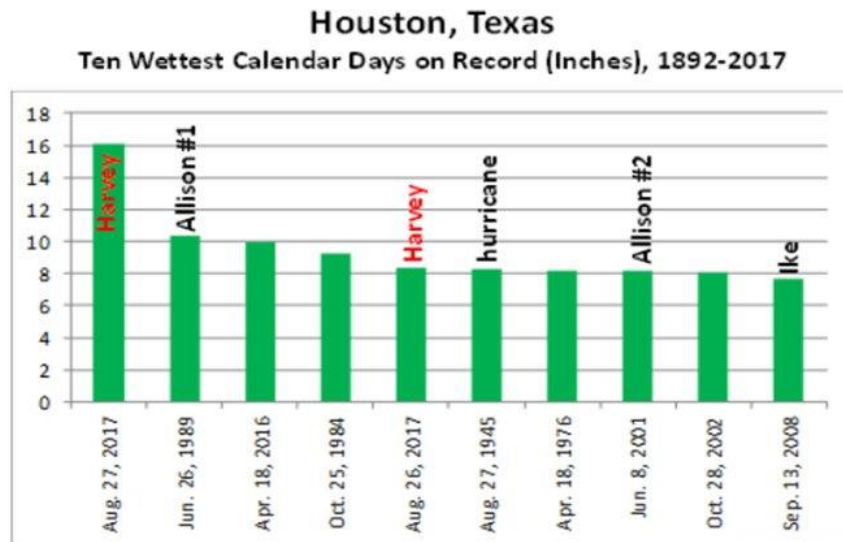
Houston's Ten Wettest Days on Record

National Weather Service Houston/Galveston

Two of the 5 wettest days on record in Houston occurred with Harvey (16.07" and 8.37").

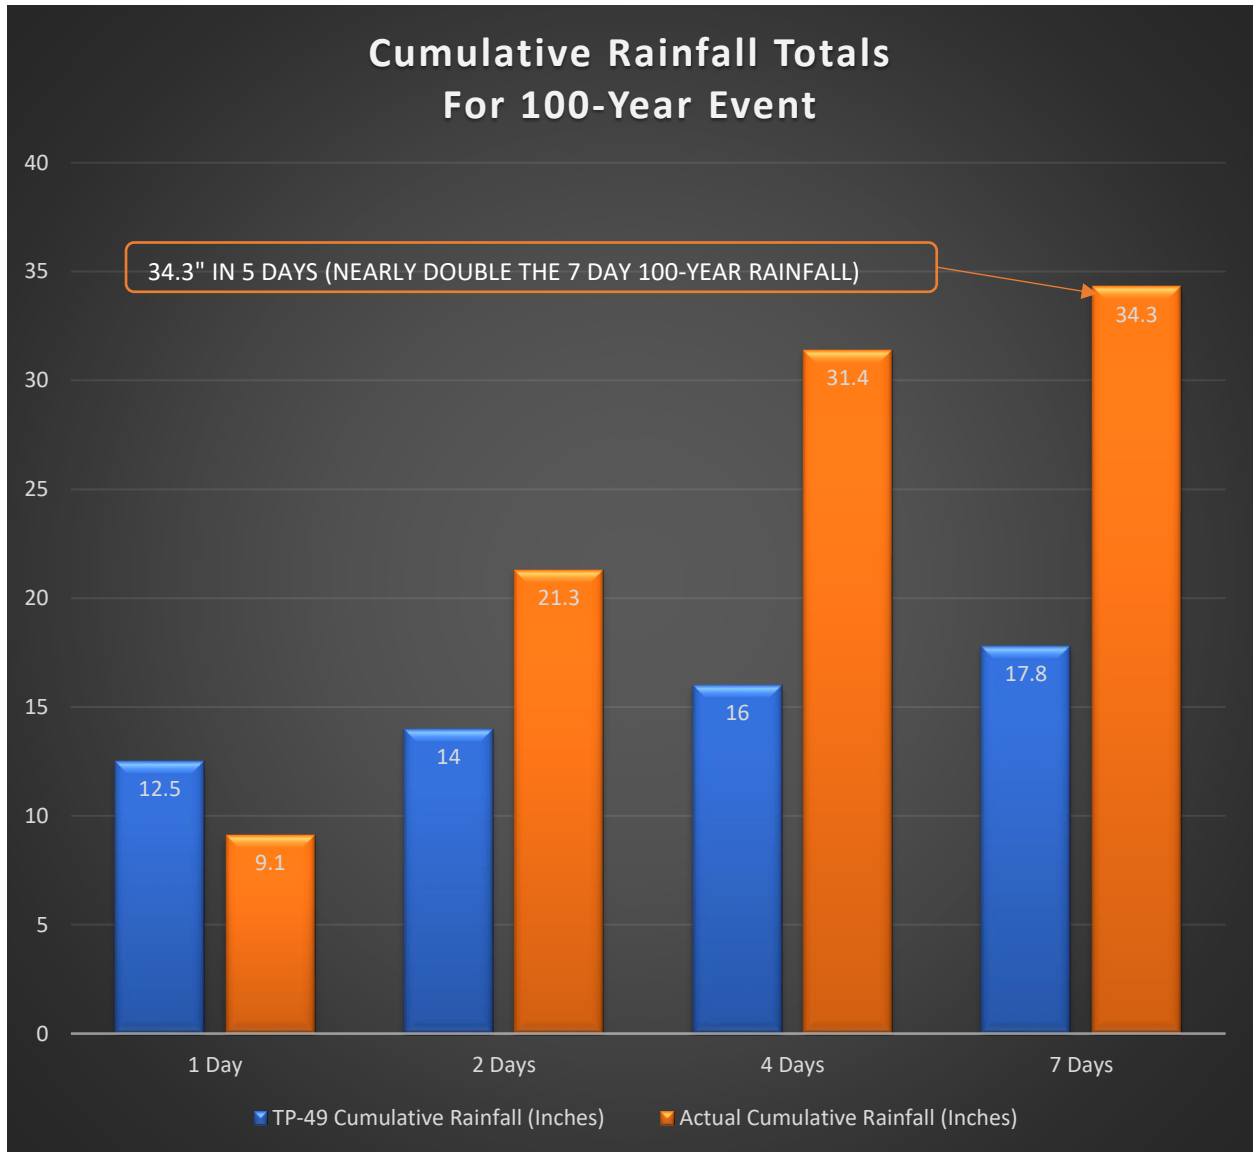
After the first 24 hours, the storm continued to produce rainfall totals that far exceed the 100-year rainfall that the drainage system is designed to accommodate. The rainfall totals easily exceed the 500-year event and will likely top the 1,000-year event when the statisticians complete their work evaluating the storm.
