LEVEE IMPROVEMENT DISTRICT #19

HURRICANE HARVEY 2017

Levee Management Services
Post Harvey Summary Report

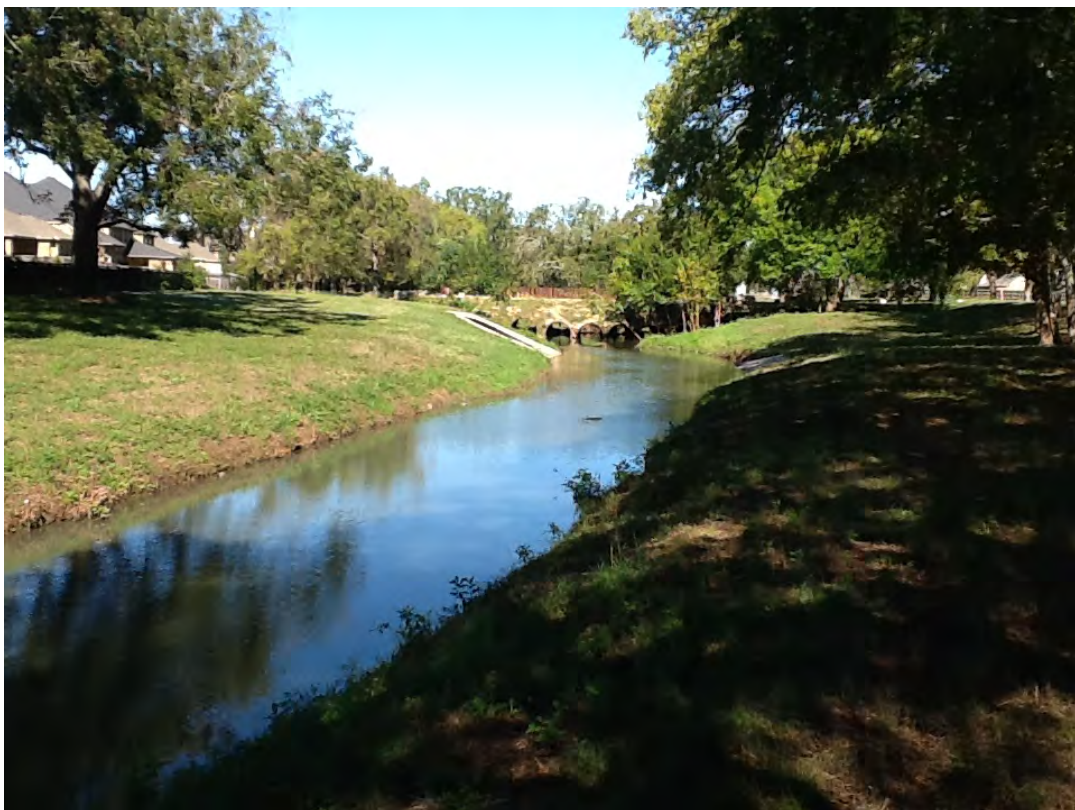
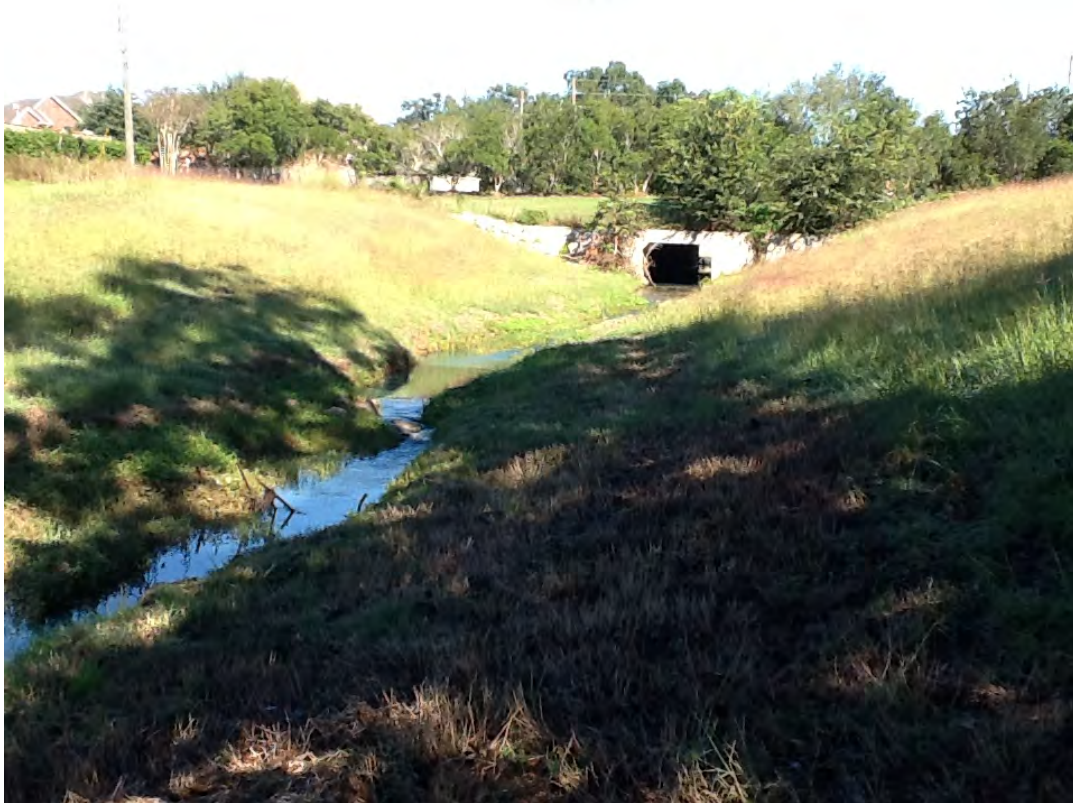
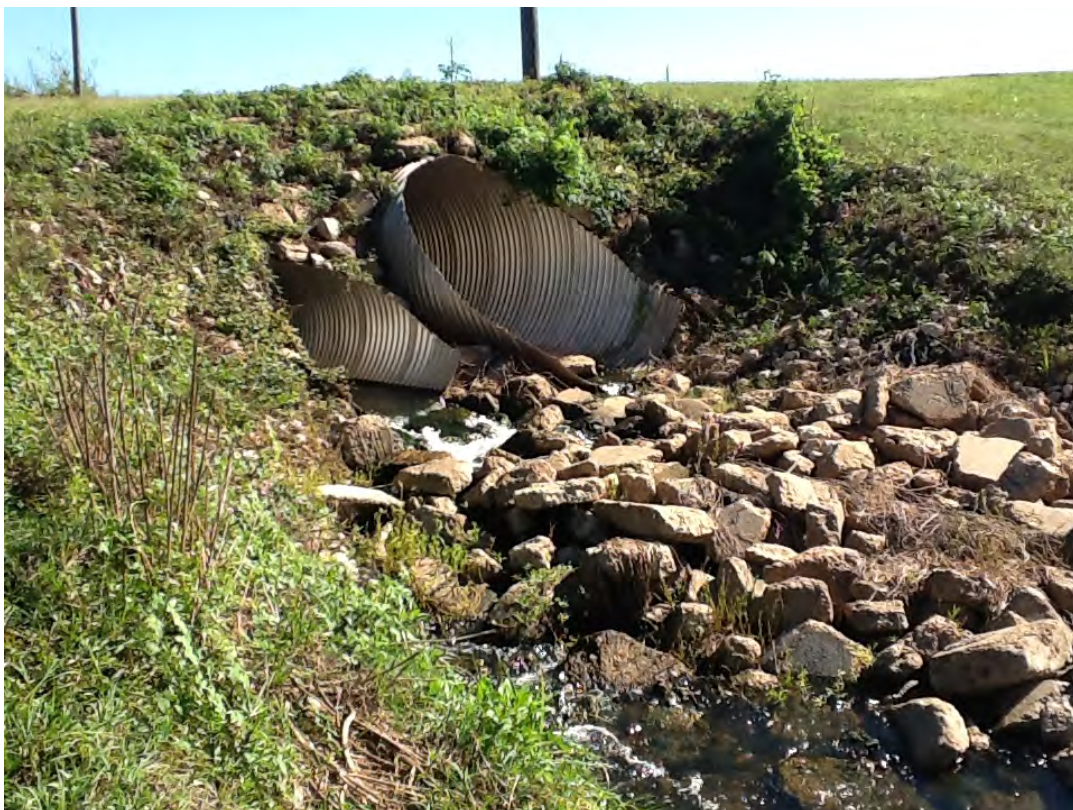
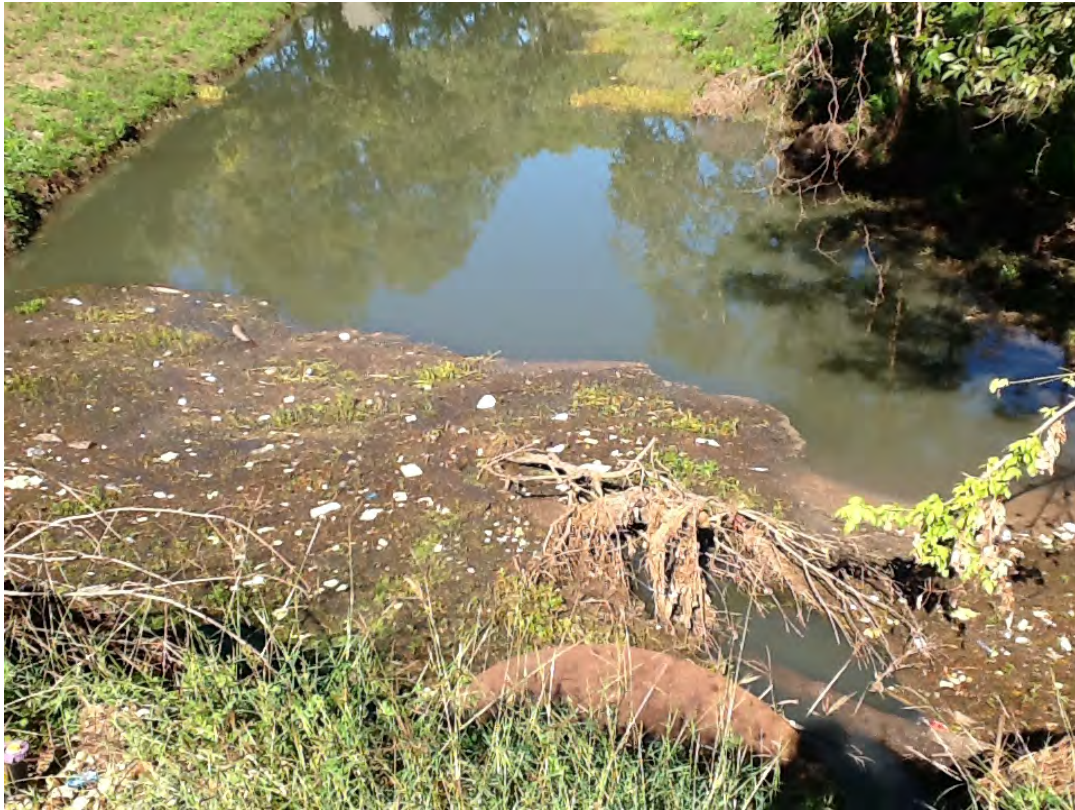
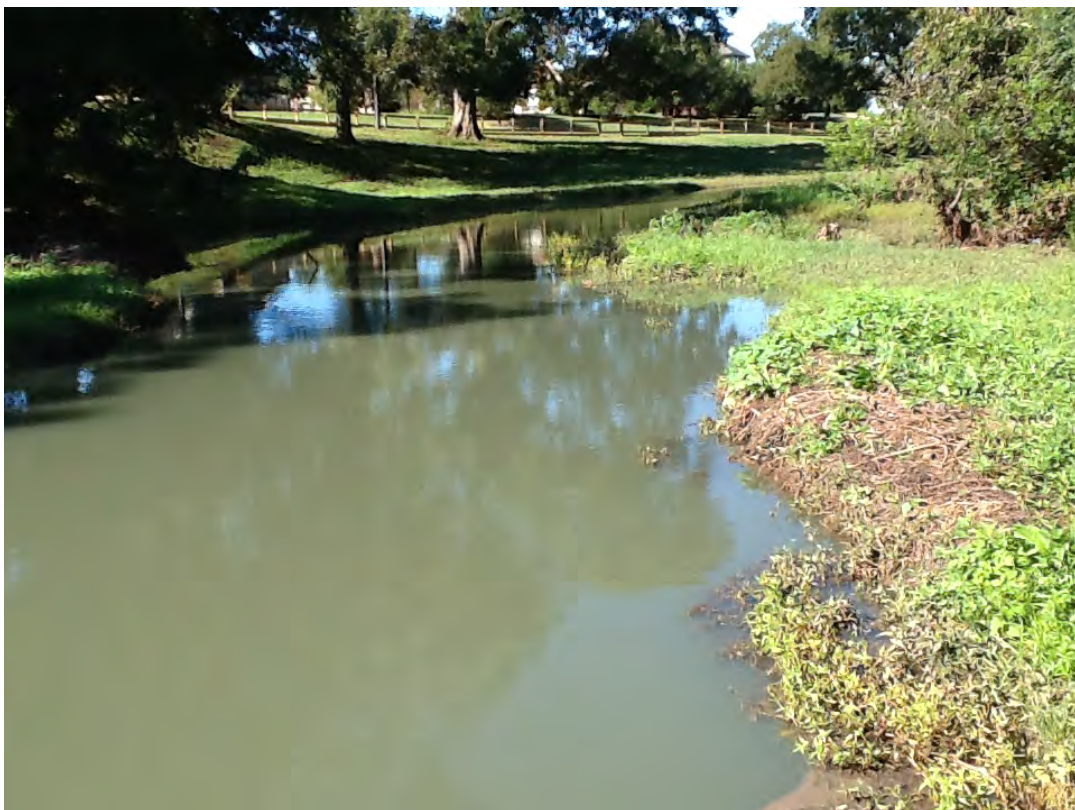
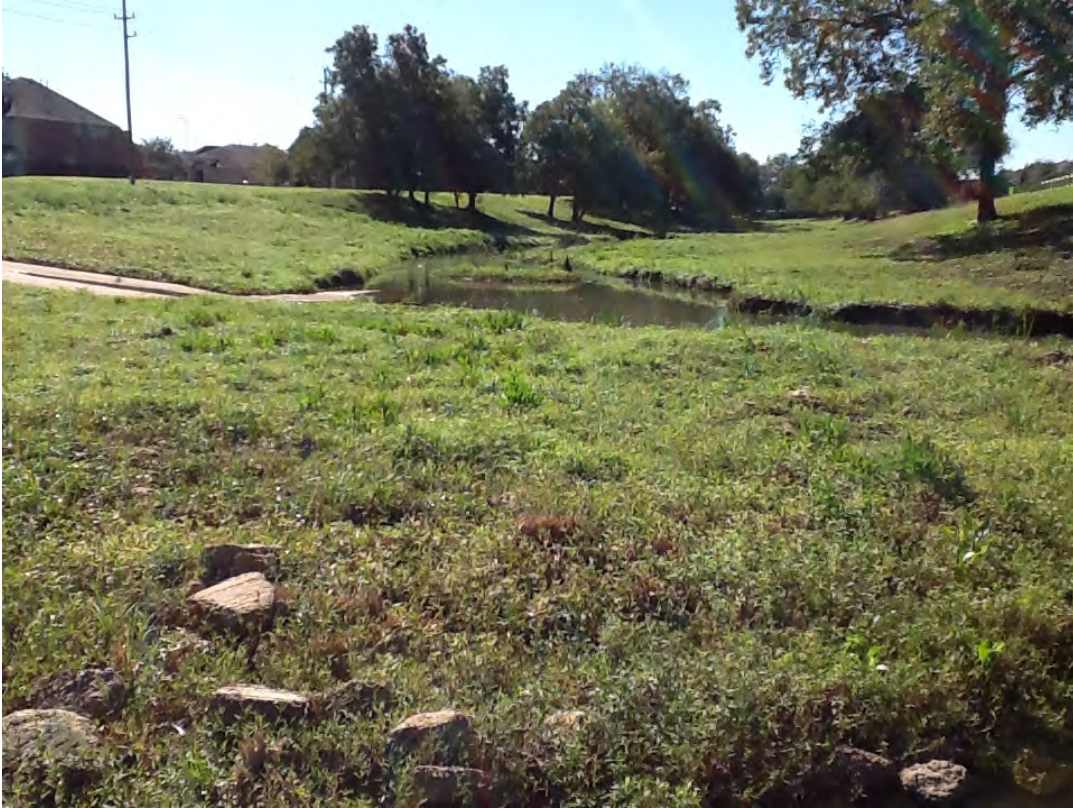
LMS completed a detailed inspection of Steep Bank Creek after Harvey. There are several areas that have down trees and limbs from the storms and water levels experienced during Harvey. An abundance of trash and debris has been left throughout the channel from natural drainage as the water receded in the district. LMS has already contracted to begin clean up in the channel and this work will continue throughout the rest of the year.
